Re: 2021 Little Green Lake Dam Inspection
GEC # 2-0413-127B

DAM INSPECTION REPORT

LITTLE GREEN LAKE DAM JUNE 2021

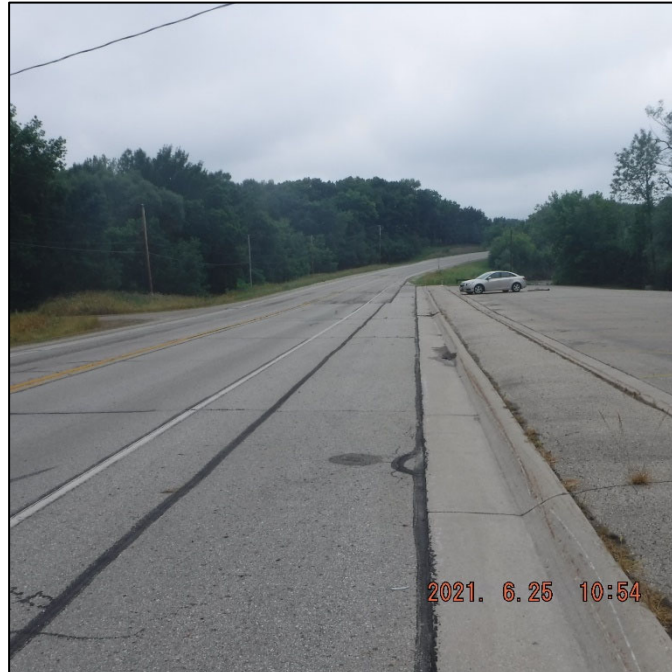
Little Green Lake Dam
Dam From Left Embankment
0121106252101.JPG

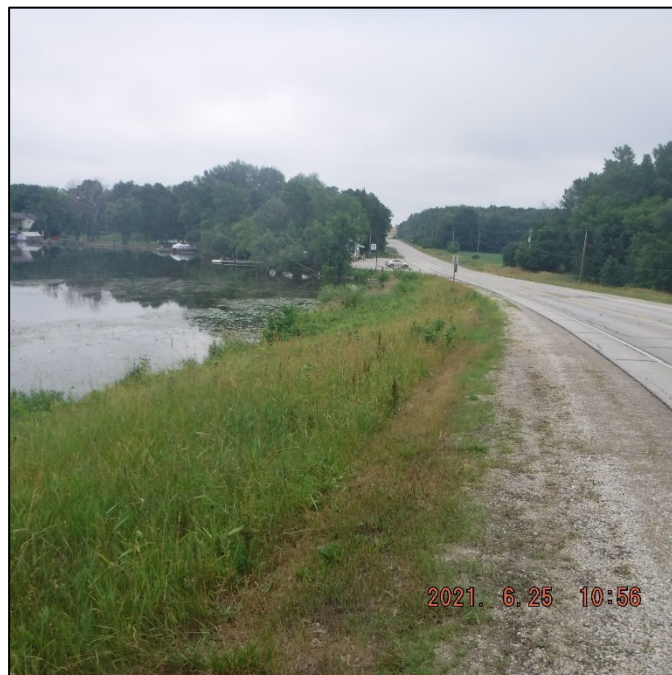
Little Green Lake Dam
Dam From Right Embankment
0121106252102.JPG

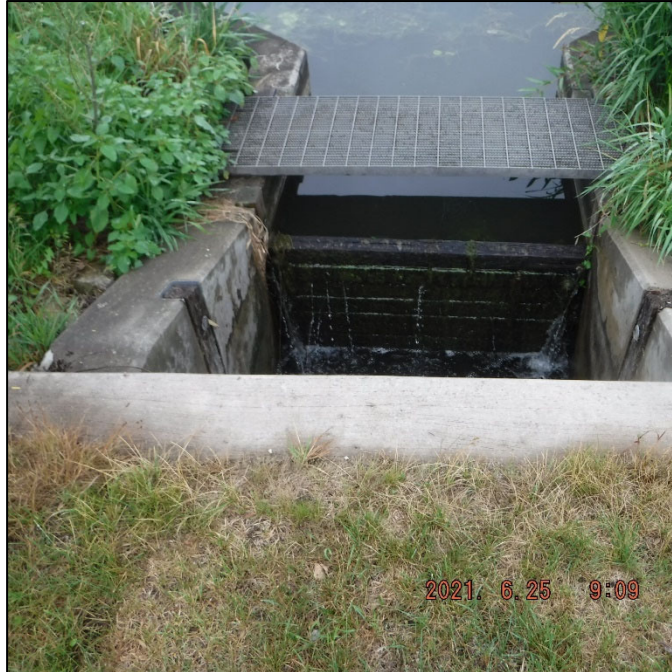
Little Green Lake Dam
View Of Upstream Concrete Dam Structure
0121106252103.JPG

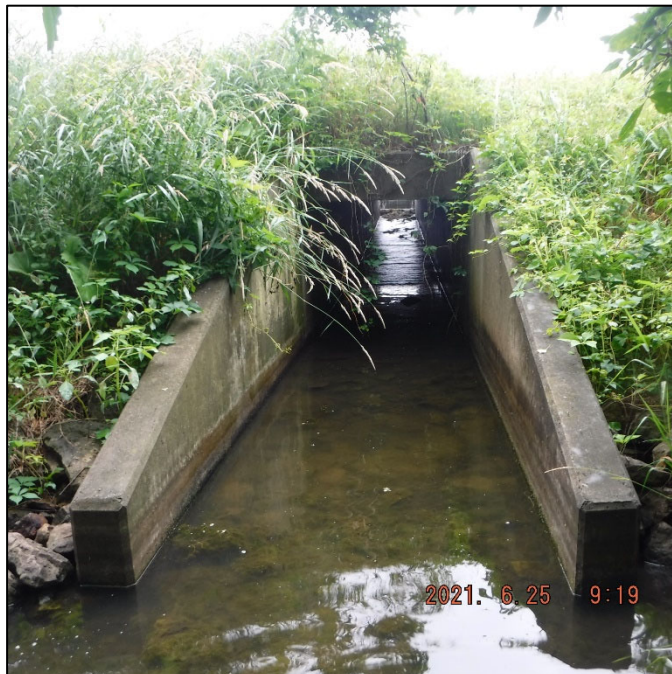
Little Green Lake Dam
View Of Downstream Outlet Structure
0121106252104.JPG

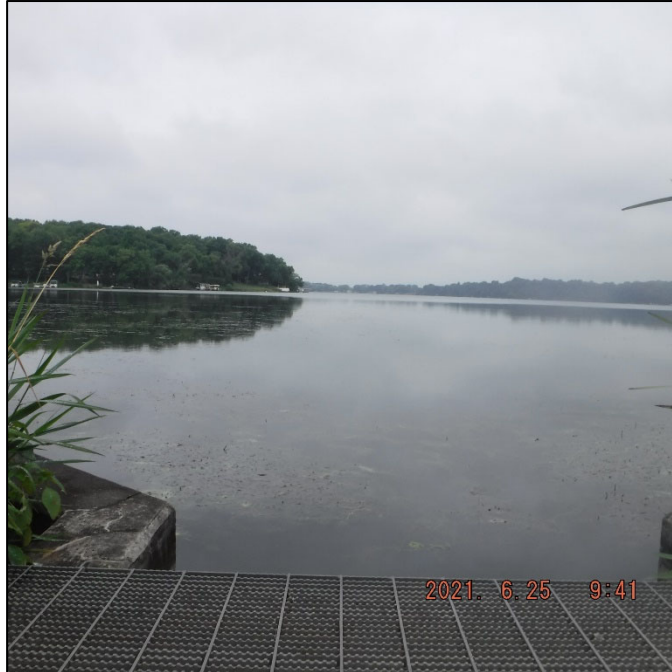
Little Green Lake Dam
Impoundment Upstream Of Dam
0121106252105.JPG

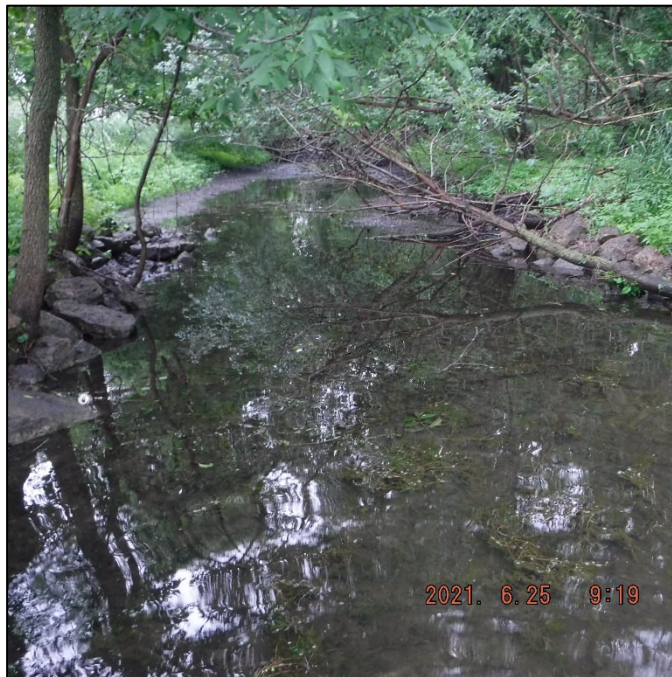
Little Green Lake Dam
Creek Downstream Of Dam
0121106252106.JPG

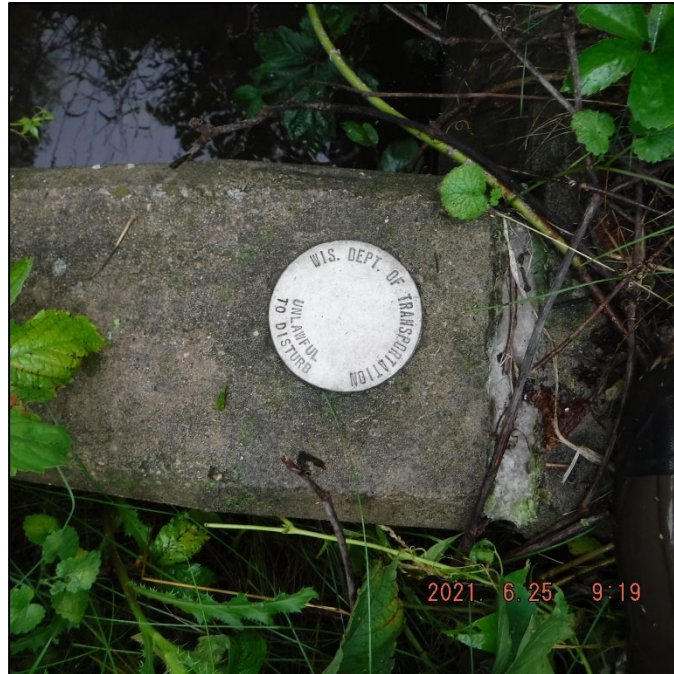
Little Green Lake Dam
DOT Monument On Left D/S Abutment
0121106252107.JPG

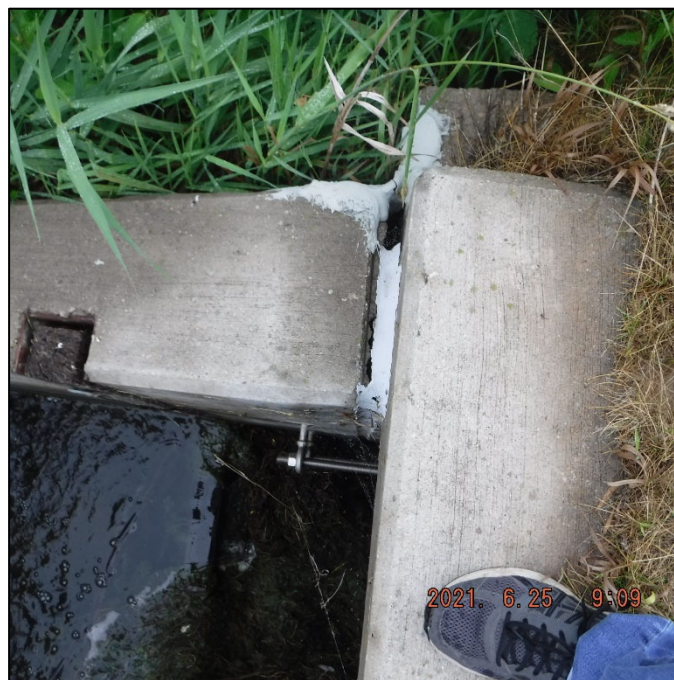
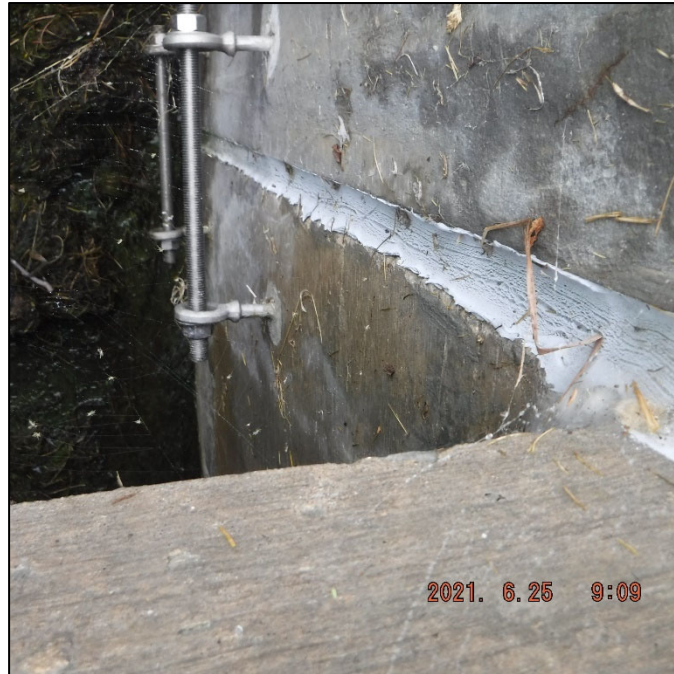
The first issue is that the joint between the concrete culvert sections and the upstream wingwalls has separated in the past. There appears to be a previous repair attempt that consists of installing steel eye bolts into the face of the concrete wingwall and first culvert section, with threaded rod bolts to tie the two sections together and prevent further separation. After the installation of the bolts, the joint was then filled with a joint filler. On the day of the inspection, it was noted that the bolted connections are holding up well, but there are leaks coming through both of the joints. It is recommended that the joints be injected with SealGuard Dual component Polyurethane grout to stop the current leaks.

E. Separated Joint / Loss of Joint Material:		x	x					<input type="checkbox"/>	<input type="checkbox"/>	x
	Location: U/S 1 1/2" to 2" Gap Between Culvert And Abutment w/ Seepage Description:

Little Green Lake Dam
Separation Of Joint At Right U/S Abutment
0121106252108.JPG

Little Green Lake Dam
Separation Of Joint At Right U/S Abutment
0121106252109.JPG

- Concrete Control Structure:
 - Repair Seepage at Concrete Joints 3-12 Months
 - Repair Hole in Flowline 3-12 Months
- Embankments:
 - Tree/Brush Removal 6-12 Months
 - Mowing With Current Season

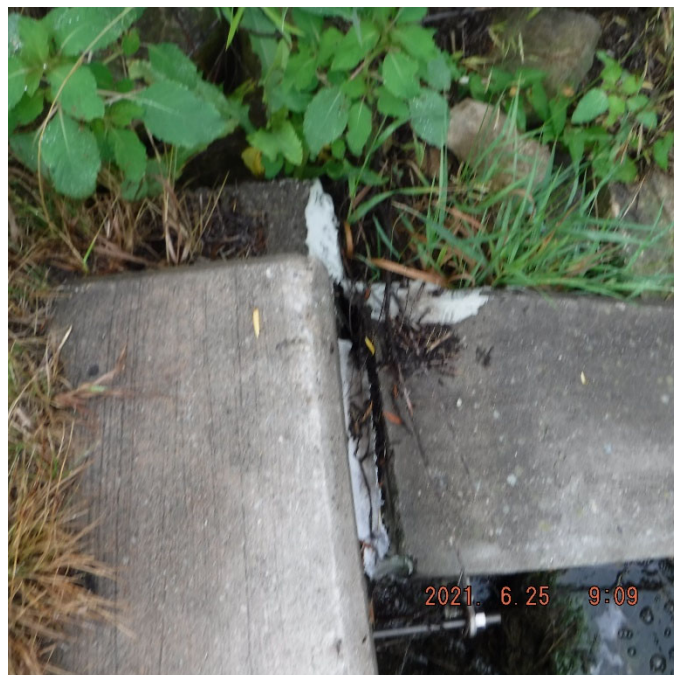
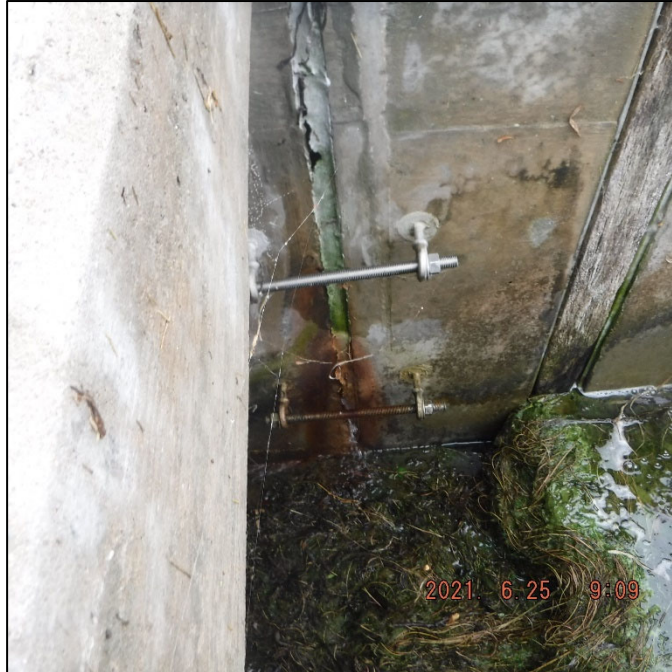
Little Green Lake Dam
Separation Of Joint At Left U/S Abutment
0121106252110.JPG

Little Green Lake Dam
Separation Of Joint At Left U/S Abutment
0121106252111.JPG

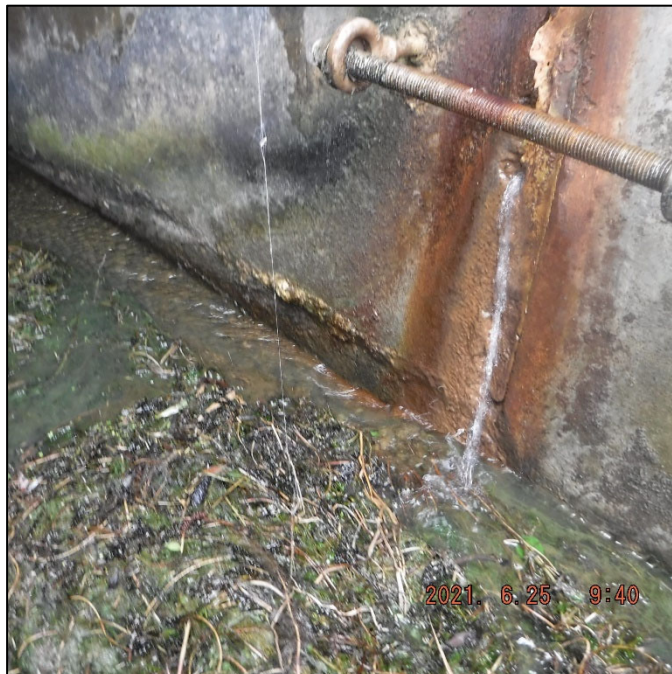
B. Stoplogs	x	x			x		
Dimensions:			4x4's 5' Length				
Condition:			Acceptable				
C. Abutments	x	x					x
Condition: *			Acceptable				
Seepage/wetness:			Minor Seepage At Joint Of Culvert To Abutment

Little Green Lake Dam
Seepage At Joint At Left U/S Abutment
0121106252112.JPG

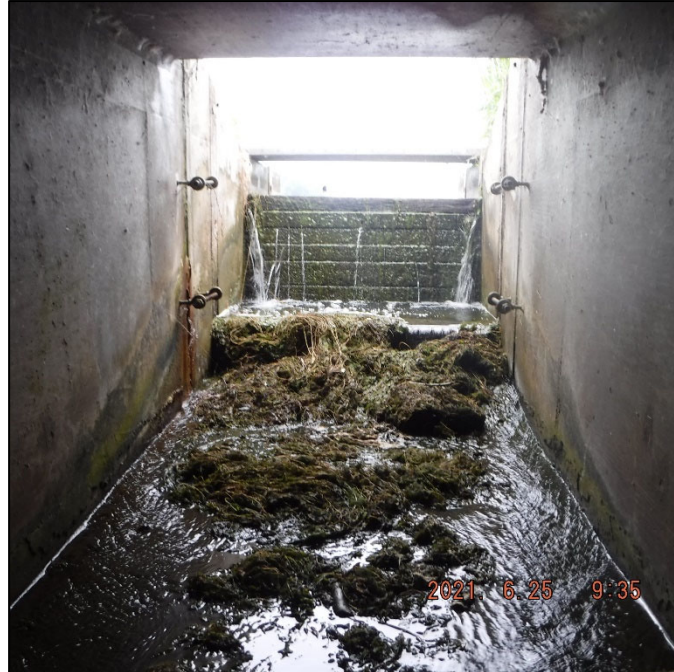
The wood stoplogs appear to be in acceptable condition at this time. There are minor leaks between some of the stoplog sections that should be monitored for worsening conditions.

Little Green Lake Dam
Leaking Between Stop Logs
0121106252113.JPG

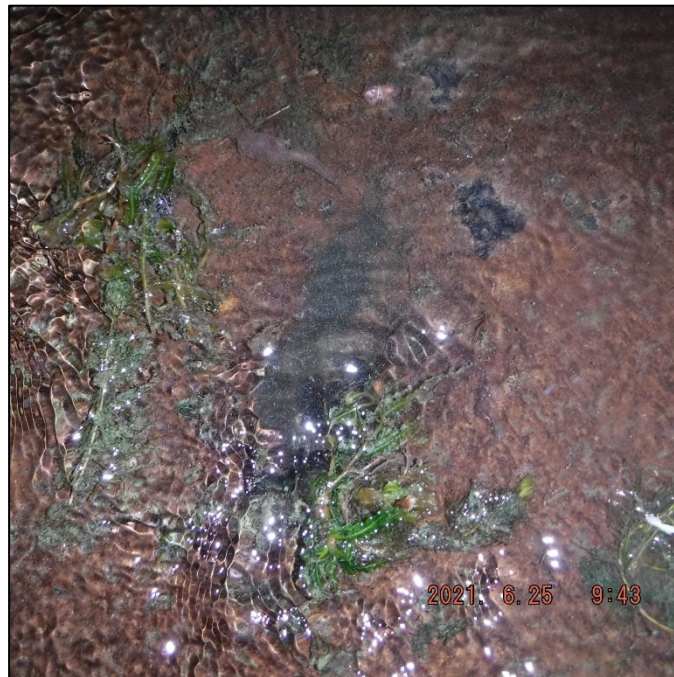
The second issue is that there is an approximately 2 in. diameter hole in the base of the concrete flowline in the culvert approximately 30 ft. from the stoplogs. It is recommended that the hole be filled with Xypex Patch'N Plug.

I. Debris							
Prevention (Rack, boom, etc.)			None				
J. Condition of Flowway							x
			2"-3" Diameter Hole Through Flow Line Concrete In Center Approximately 30' From Stoplogs

Little Green Lake Dam
Hole In Base Of Flow Line
0121106252114.JPG

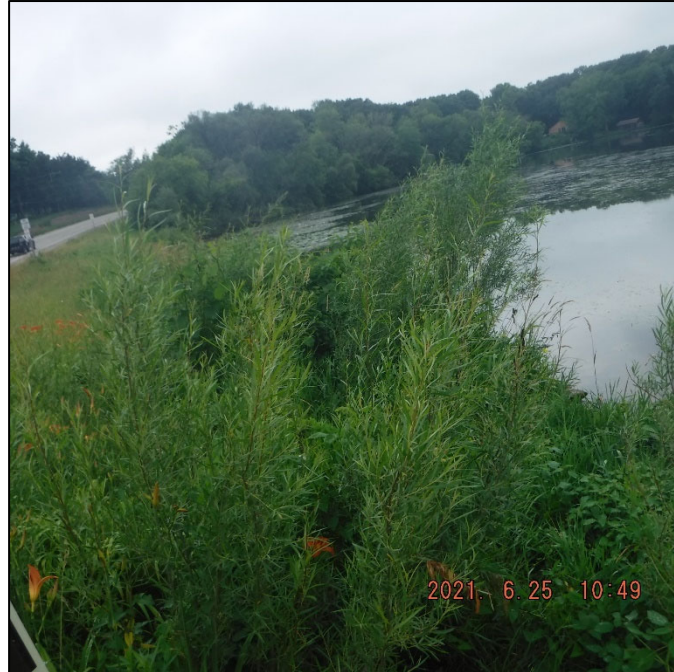
The embankments of this dam are in good condition. There is generally well-established vegetation cover that is overgrown. There is woody vegetation on the right upstream embankment near the concrete control structure, and directly above the downstream culvert. It is recommended that the vegetation be mowed on both the upstream and downstream embankments, and remove all woody vegetation around the control structure.

Little Green Lake Dam
Woody Vegetation On U/S Embankment
0121106252115.JPG

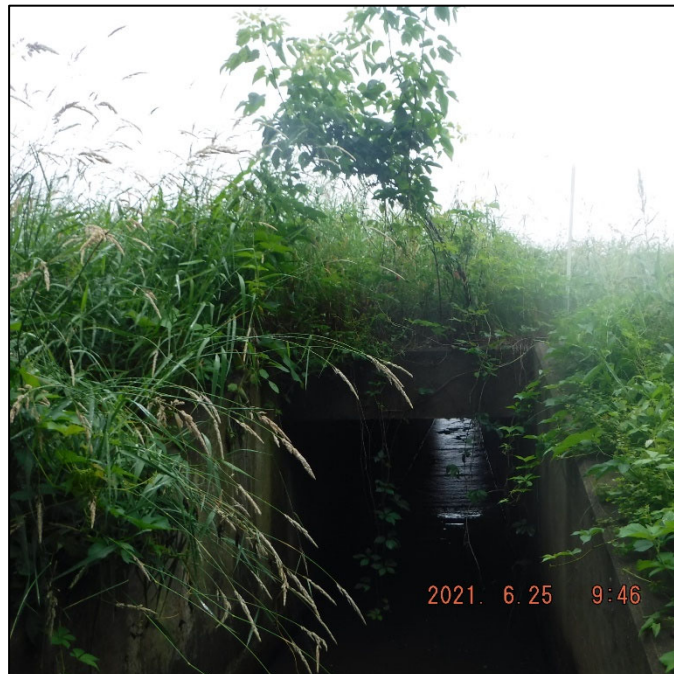
B. Brush Quantity (sparse, dense): Location:	x	x	Sparse D/S Embankment Right Of Dam			
C. Ground cover Type (grass, crown vetch, other): Quantity (bare, sparse, adequate, dense): Appearance (too tall, too short, good):	<input type="checkbox"/>	<input type="checkbox"/>	None			
2 Erosion	x		No problem	Not applicable	Could not inspect

Little Green Lake Dam
Woody Vegetation On D/S Embankment
0121106252116.JPG
